Manhole Inspection Summary

Manhole # S43A__005MH

Location Address: **Orleans**

Cross Street: **Broadway**

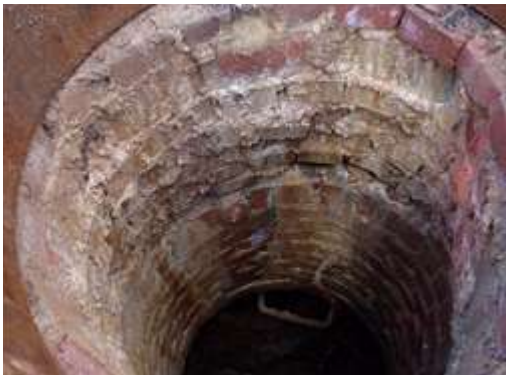
Defect 2

Infiltration: ☐ None ☒ **Joint** ☐ Cracks ☐ Mortar ☐ Roots ☐ Wall

Infiltration: ☐ None ☐ Joint ☐ Cracks ☐ Mortar ☐ Roots ☒ **Wall**

Infiltration

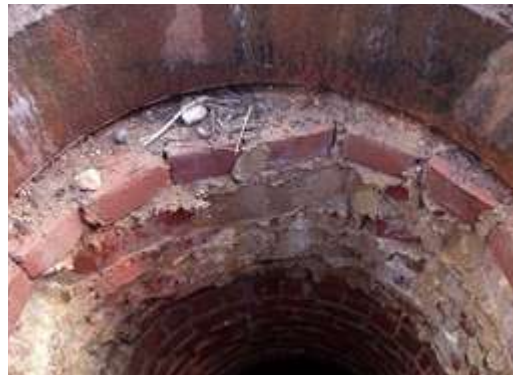
Defect 1

Offset: **2** (in.)

☒ **Leaks**

Offset Frame; Loose Bricks

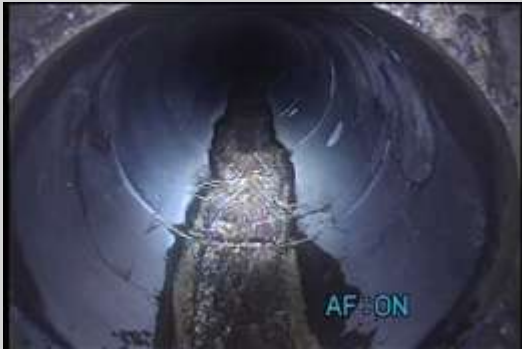
12 O'Clock Outflow

24 in. Circular Gravity Sewer
Pipe Out @ 12 O'Clock

Pipe Height: **25.2** (in.) Rod and Bar (Angled)
Pipe Material: **Clay** ☐ Pipe Lined
Invert Depth: **10.90** (ft.) Flow Characteristics: **Slow**
Deposits: ☒ None ☐ Mud ☐ Sludge ☐ Debris ☐ Grease
Silt Depth: (in.) Deposits Extent:
Infiltration: **None** Pipe Seal Cond: **Sound**

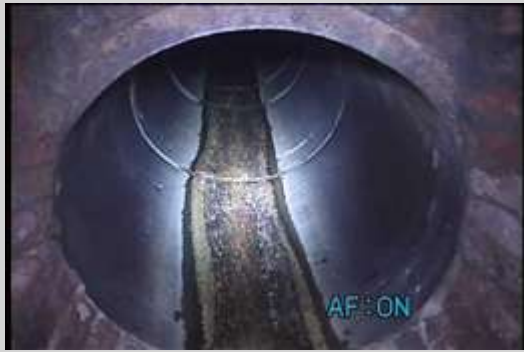
6 O'Clock Inflow

24 in. Circular Gravity Sewer

Pipe In @ 6 O'Clock

Pipe Height: **24** (in.) Rod and Bar (Angled)

Infiltration: **None** Pipe Seal Cond: **Sound**

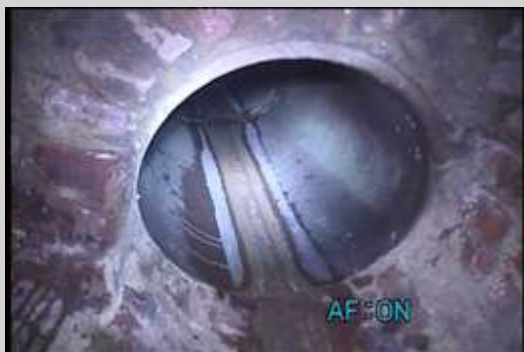
9 O'Clock Inflow

15 in. Circular Gravity Sewer

Pipe In @ 9 O'Clock

Pipe Height: **13.2** (in.) Rod and Bar (Angled)

Infiltration: **None** Pipe Seal Cond: **Sound**
